Post-tensioned Multistrand Anchorage Capacity Deterioration Due To Corrosion: John Day Lock Project

by Robert Ebeling, Richard Haskins, David Scofield, John Hite, and Ralph Strom

John Day Lock. The John Day Lock and Dam Project is 216 miles upriver from the mouth of the Columbia River near the city of Rufus, OR. The authorized primary project purposes are navigation and power generation. The project consists of a navigation lock, spillway, powerhouse, and fish passage facilities. John Day Lock was designed and constructed in the 1950's and 1960's simultaneously with the four Snake River locks and dams. The lock is 650 ft long by 86 ft wide and possesses the highest single lift (113 ft) in the Corps of Engineers. The project design was based on the Snake River locks with about 100 ft lifts and scaled to the John Day project conditions. Construction of John Day Lock and Dam was completed in 1971. Structural cracks in the south filling/emptying culvert were first noticed in 1975 and continued to

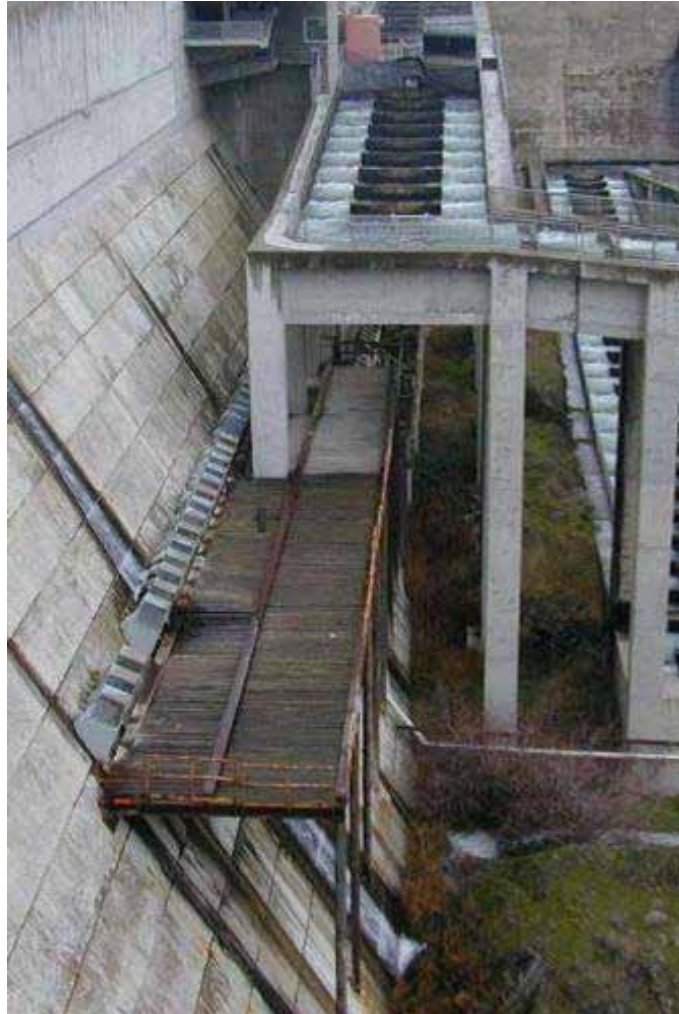
Pat Hunter from the John Day Project led the tour on 31 August. Figure 3 shows the anchor pedestals (i.e., reinforced concrete reaction blocks) and anchor head protective covers protruding from the outside face of the south lock wall. These are some of the upper anchors shown in Figure 1. Figure 4 shows the original anchor head installed in 1981. This anchor head was specially manufactured for this project with a threaded head (refer to Figure 4). This special provision facilitates the connection of a specially manufactured “coupler” to the jacking equipment used for lift-off testing. This feature is unique to the John Day anchorage.

Figure 3. Anchor head pedestals and protective covers along the south lock wall access deck.

- f. Water on the Columbia is characteristically soft which further contributes to corrosiveness.
- g. It was noted that there are extreme seasonal temperatures and the pedestals containing the anchor heads (Figure 3) are exposed to these conditions.

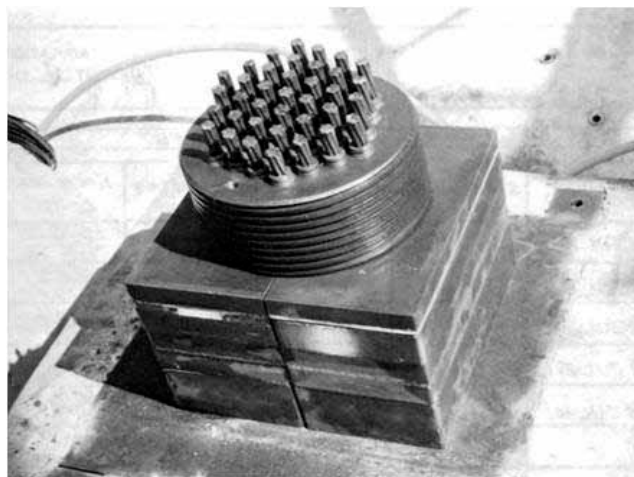
Figure 4. Original 1981 threaded anchor head with spacers and wedges resting on the anchor pedestal.

SIGNIFICANT FINDINGS: The research performed to date and the investigation into the John Day Project, have revealed several key issues for the multistrand anchors. The unique features of John Day Anchors for lift-off testing capabilities are not common to most all other ground anchors. The threaded anchor head was specially manufactured for this project and facilitates the connection of a custom made “coupler” to the jacking equipment used for lift-off testing. This emphasizes the need to develop NDE testing techniques that will be vital for assessment of anchors at other sites and also the John Day Project. Forensic inspection of a “decomposed” anchor head and pedestal of a corroded John Day anchor should provide useful insight into corrosion behavior of the anchorage system, especially the corrosion stress, stress concentration, or loss of cross section at the gripping wedge. The load transfer zone for the bonded section of the anchors needs to be studied carefully to try and avoid cracking of the foundation and the subsequent flow of water into the anchors.

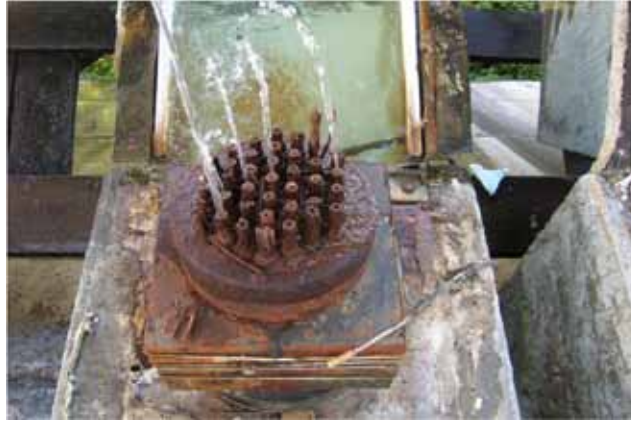
FIELD OBSERVATIONS: A significant number of anchor failures seem to initiate with the failure of the center wire known as the "king" or "core" wire. The center wire has a larger diameter than the outer wires to assure the outer wires bear on the center wire and grip it as there is no other means of keeping tension in the center wire. This failed wire has been observed either retracting into the seven-strand grouping or protruding outwards (and above the tops of the seven-strand wire groups). For those wires protruding, the length has been on the order of six to eight inches. This length likely corresponds to the distance between the tip of the gripping wedge and the top of the wire above the anchor head. Retraction of the center wire could indicate a loss of section due to corrosion where the diameter has reduced enough to prevent the outer wires from bearing on it. Protrusion of the center wire may indicate a corrosion failure. Figure 5 shows flow of water through the anchor from the lock operation, and the loss of the center wires can also be seen. Potential contributing factors to strand failure near the anchor head are listed below:

- a. Temperature,
- b. Wetting and drying action leading to a concentration of dissolved oxygen near the anchor head
- c. Corrosion stress, stress concentration, or loss of cross section at the gripping wedge,
- d. Increased corrosion potentials (electrical potentials).

Figure 5. 2008 inspection (and lift-off testing) of multi-strand tendons showing loss of center wire and flow of water through several of the 7-stand wires.

- a. If the king wire is straight an argument can be made that the six surrounding wires will have less tension (longer) and add a shearing force;
- b. Water appears to be moving up the length of cable. One fundamental question is what path the water is taking toward the anchor head. For example, is the water moving up around the “king” wire, inside the sheath, or outside the sheath. This question contributes to the motivation for removing an anchor head and recovering and inspecting the subsurface cable;
- c. A secondary question is, where does the sheath terminate and does this additionally contribute to corrosion issues occurring mostly toward the anchor head;
- d. Recovery of a nonfunctional anchor head would allow for a detailed assessment of points of access for insertion of NDE / mitigation technologies.

ERDC Recommended Field Tests for John Day Multistrand Anchors. Field activities will benefit the investigation of the multistrand anchors by helping to determine some of the corrosion, deterioration, and failure issues. Inspection and recovery of the top section of the anchor head, for anchors that have experienced a loss of tension, is desired. The results of the previous lift-off tests can be used to identify these anchors.

- a. Perform a lift-off test;
- b. Remove shim plates;
- c. Release tension;
- d. Saw cut with wire saw at base of trumpet;
- e. Photograph and recover head, grip wedges, and cables.
